PENNSYLVANIA  
GALLO DAM

NDS I.D. No. PA - 00233  
PENNDER I.D. No. 56 - 91

PHASE I INSPECTION REPORT  
NATIONAL DAM INSPECTION PROGRAM

SEPTEMBER 1979

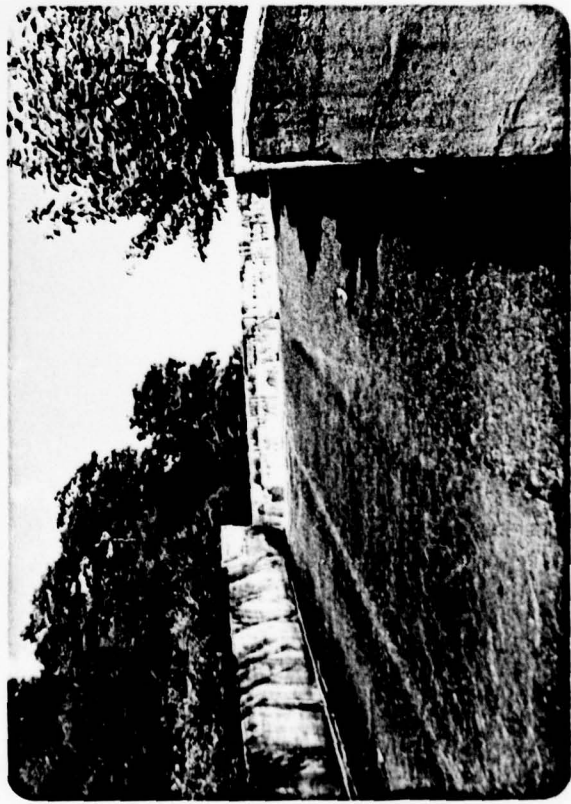
3

A portion of the lower end of the spillway was dislodged in the past, necessitating some remedial work (See Photograph 4). Also, the weir crest was re-shaped and raised in 1969 by approximately 2 feet, while approximately 6 inches of concrete was added to the spillway weir sidewalls (See Photograph 3). The modification has resulted in the reduction of spillway capacity. The spillway crest addition is cracked and somewhat rotated (See Photograph 3), possibly from ice pressure.

1. Spillway. The spillway was modified in 1969 when two feet of concrete was added to the weir crest in order to provide additional reservoir depth and surface area for recreational use. This spillway cap has since cracked and rotated somewhat (see Photograph 3). Since the cap only represents the upper two feet of the weir crest, the situation is not considered critical; however, it should be noted that the weir was also reshaped and the spillway sidewalls were not raised accordingly when the crest was raised, both of which have led to a reduction in the actual capacity of the spillway.

View of the spillway from near the plunge pool. Note concrete caps that were added to the weir crest and left sidewall (also to the right sidewall). Also note the cracking of the weir, and the apparent rotation of the weir cap.

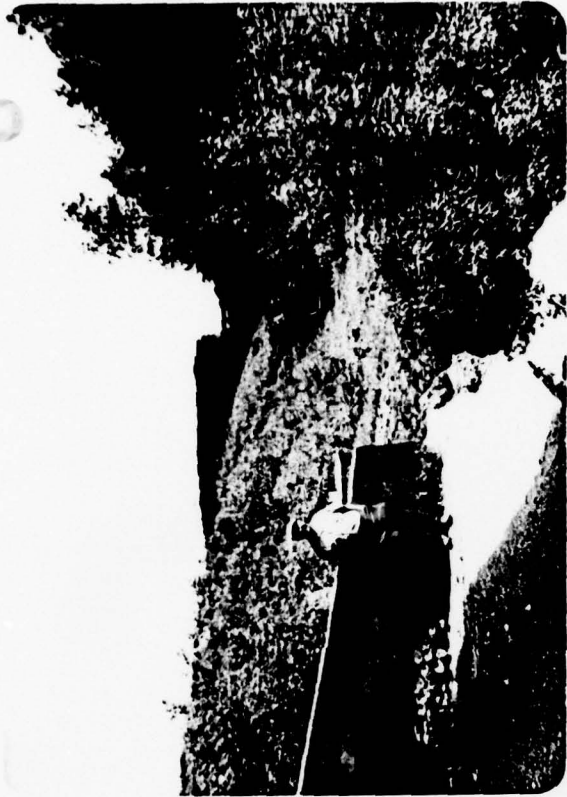
2

The facility is served by a chute channel spillway, with discharges controlled by a free overfall, concrete weir structure. The spillway is located near the right abutment, and has a crest length of 39 feet. In addition, the facility is equipped with a 18-inch diameter steel pipe encased in concrete used as a low level outlet as well as a 16-inch diameter steel siphon (see Photograph 2) which was installed in 1973.

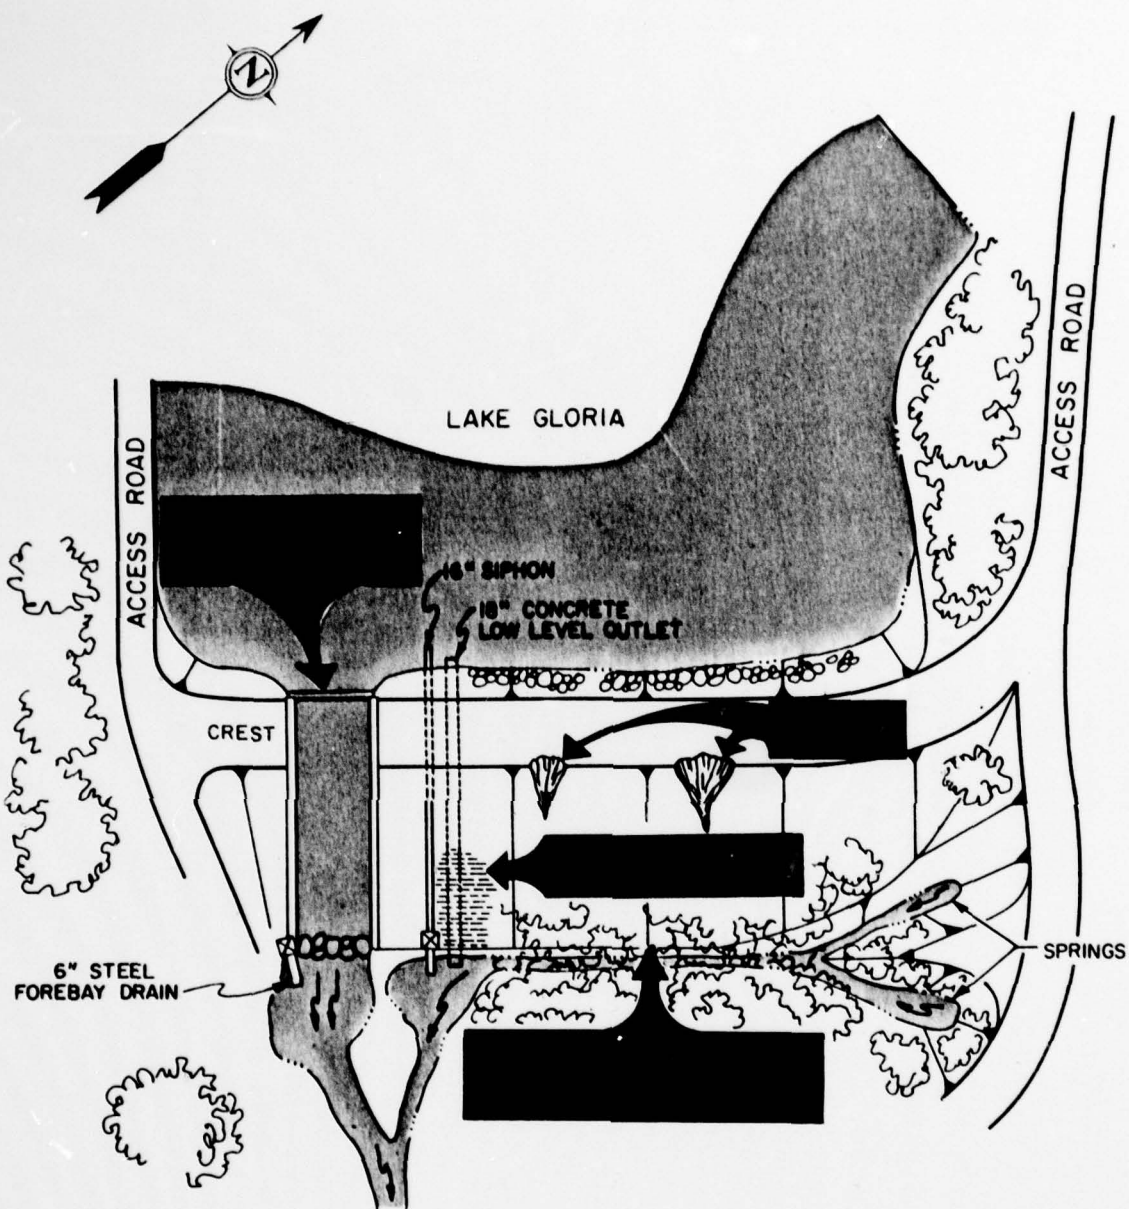
FIGURE 1 - GALLO DAM  
GENERAL PLAN  
FIELD INSPECTION NOTES

b. Embankment. Observations made during the visual inspection indicate the embankment to be in fair condition. Deficiencies include a heavily overgrown and brush-strewn downstream face, an uneven downstream slope with erosion ditches at several locations (See Figure 1), and swamp-like conditions immediately downstream of the embankment toe.
